ENGINEERING FLIGHT TEST OF THE AH-1G HUEYCOBRA HELICOPTER EQUIPPED WITH THE XM-28 CHIN TURRET WITH TWIN XM-129, 40MM GRENADE LAUNCHER

PHASE B

PART 4

FINAL REPORT

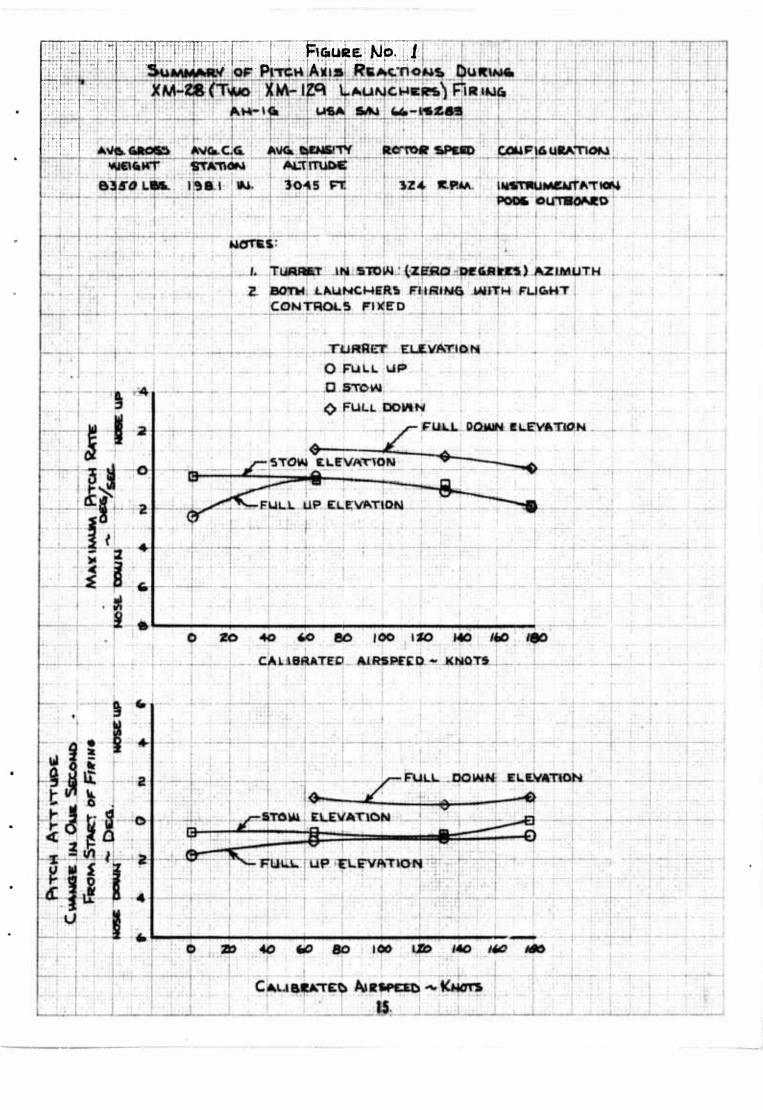
- 10. Figures 1 through 3, appendix 11, summarize the firing reaction about each aircraft axis as a function of airspeed and turret position. Pitch axis reactions were very small as shown in figure 1. The highest reaction recorded was 2.4 degrees per second (deg/sec) nose down. This rate was obtained in a hover with the turret at "full up" elevation. At increased airspeed, pitch reactions were smaller. Turret azimuth has a negligible effect upon aircraft

pitch reaction, however, turret elevation determined the direction of the pitch reaction. Full up elevation or stow position caused a nose down pitching, while full down elevation caused a nose up pitching. At no time were the magnitudes or characteristics of the pitch reactions objectionable to the pilot.

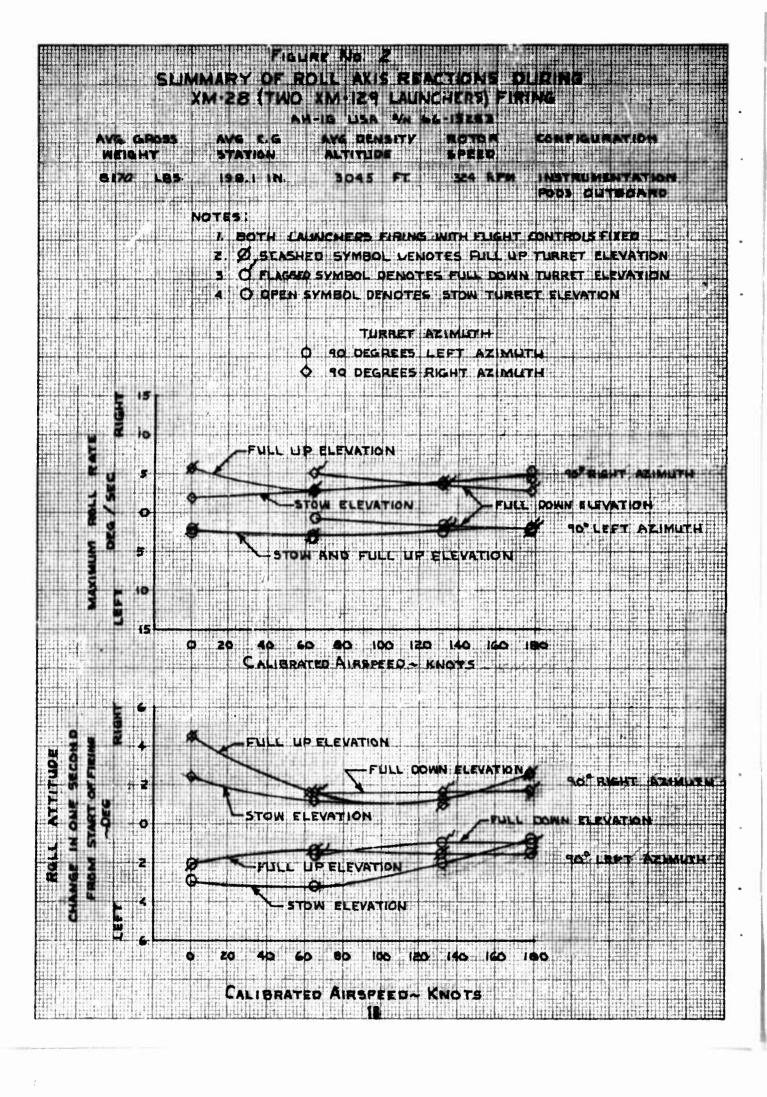
- 11. Roll axis reactions are summarized in figure 2, appendix II. There were no objectionable roll axis reactions caused directly by firing the XM-129,40 mm grenade launchers. Generally, these reactions were approximately one-half of those caused by the twin XM-134 miniguns firing at high rate for similar flight conditions. The maximum roll rate reaction recorded was 5.7 degrees per second (deg/sec) right. This rate was obtained in a hover, firing at 90-degrees right azimuth, and full up elevation. The magnitude of the roll reaction was primarily influenced by turret azimuth. Maximum roll rates were observed at 90-degrees left and right azimuth. The direction of the reaction was the same as the turret azimuth. Firing to the right caused a right roll. At zero azimuth the roll reaction was negligible.

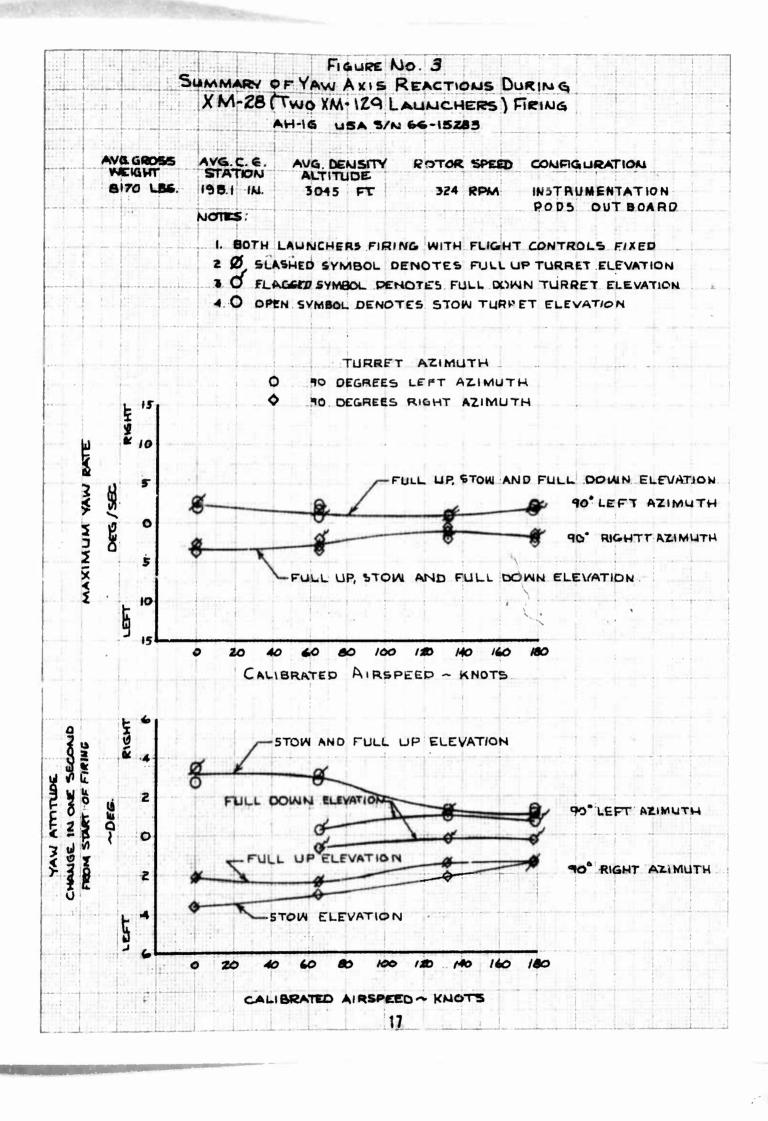
- 13. Yaw axis reactions are summarized in figure 3, appendix II. Yaw reactions were maximum at 90-degrees left and right turret azimuths, but were not objectionable at any conditions. At any turret azimuth, turret elevation had a negligible effect upon the yaw rate reaction. The maximum yaw rate recorded was 3.8 deg/sec left. This rate was obtained in a hover with the turret position 90-degrees right. The direction of the yaw reaction was always opposite the turret azimuth. Firing to the right caused a left yaw. The small yaw reaction should not present any target tracking problem to the copilot/gunner.
